**DELTA DAM**

**ONEIDA COUNTY, NEW YORK  
INVENTORY NUMBER NY 6**

**PHASE 1**

**INSPECTION REPORT  
NATIONAL DAM  
SAFETY PROGRAM**

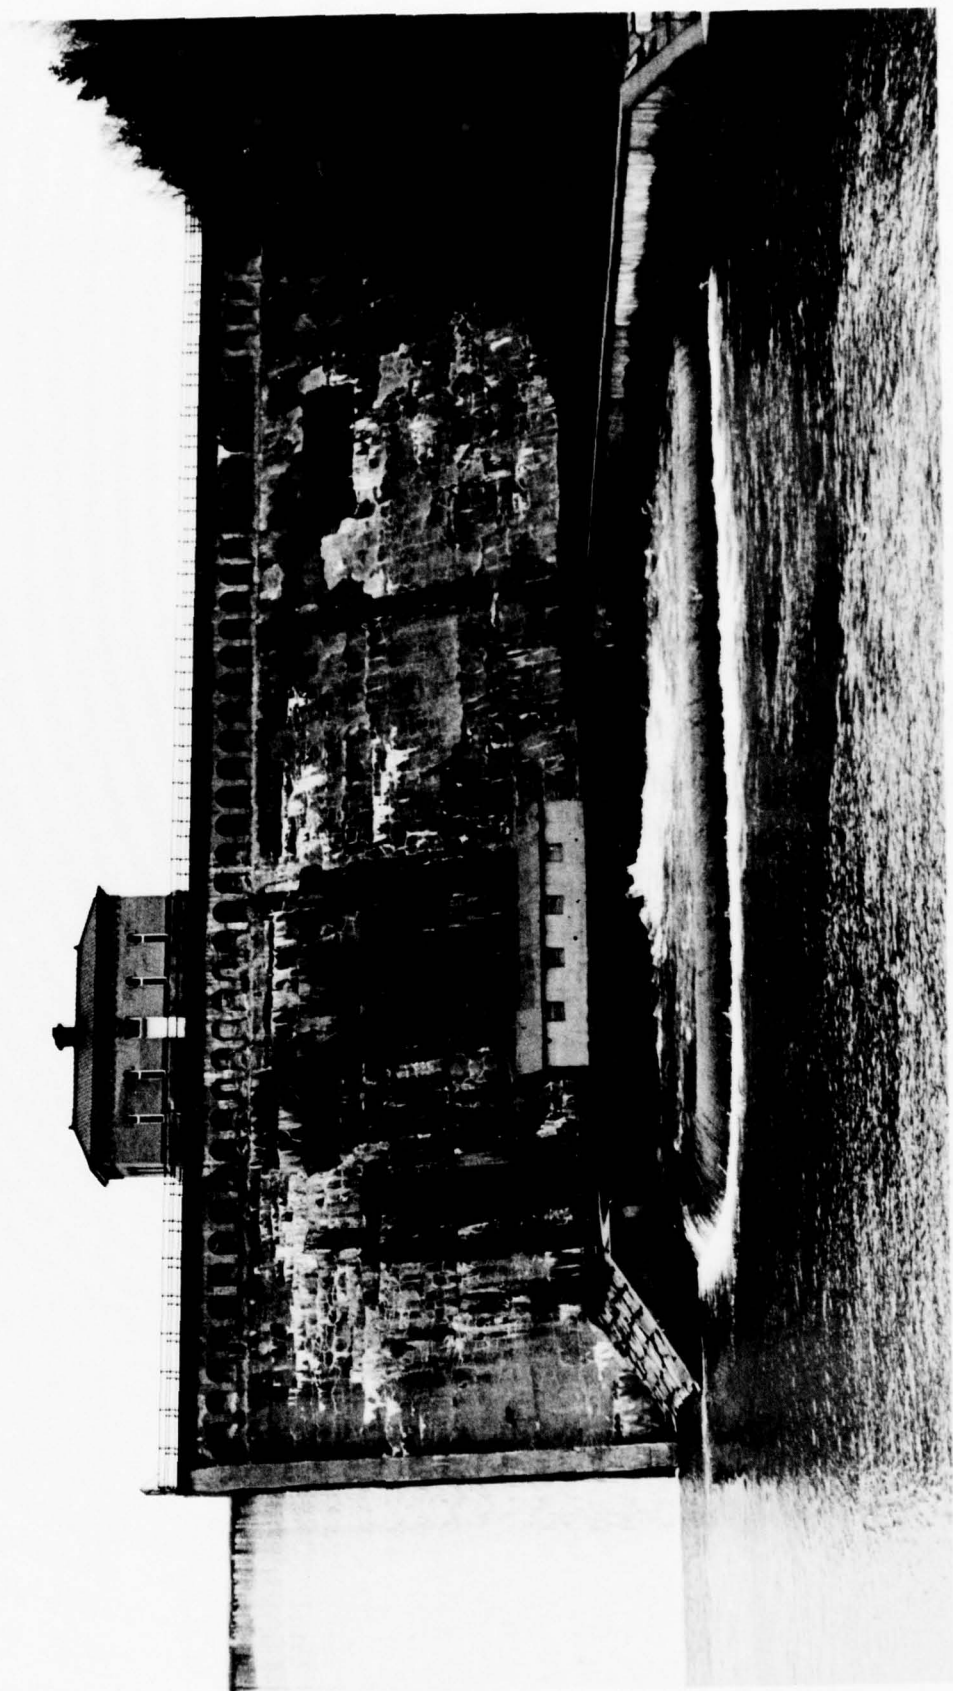
PLATE 2

2. Left abutment portion of dam from downstream.  
Note: Deterioration of gunite facing, seepage.  
Visible: Old gate house at toe, stilling pools for principal and emergency spillway.

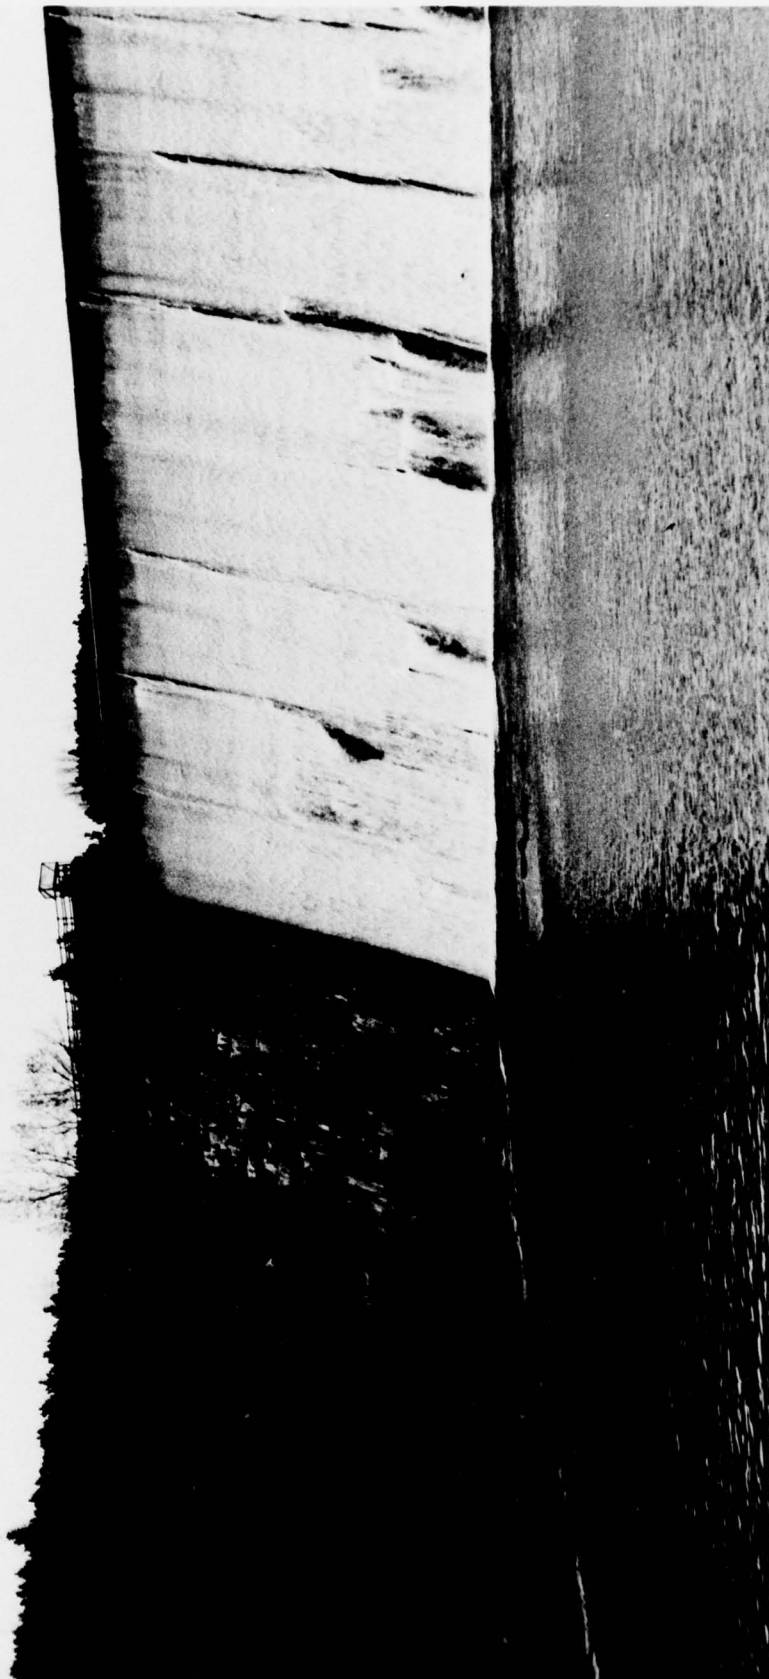
PLATE 3

3. Right portion of dam from downstream.  
Note: Deterioration of gunite facing, sprays in spillway apparently caused by deterioration in concrete.  
Visible: Stilling pool, rip rap protection.

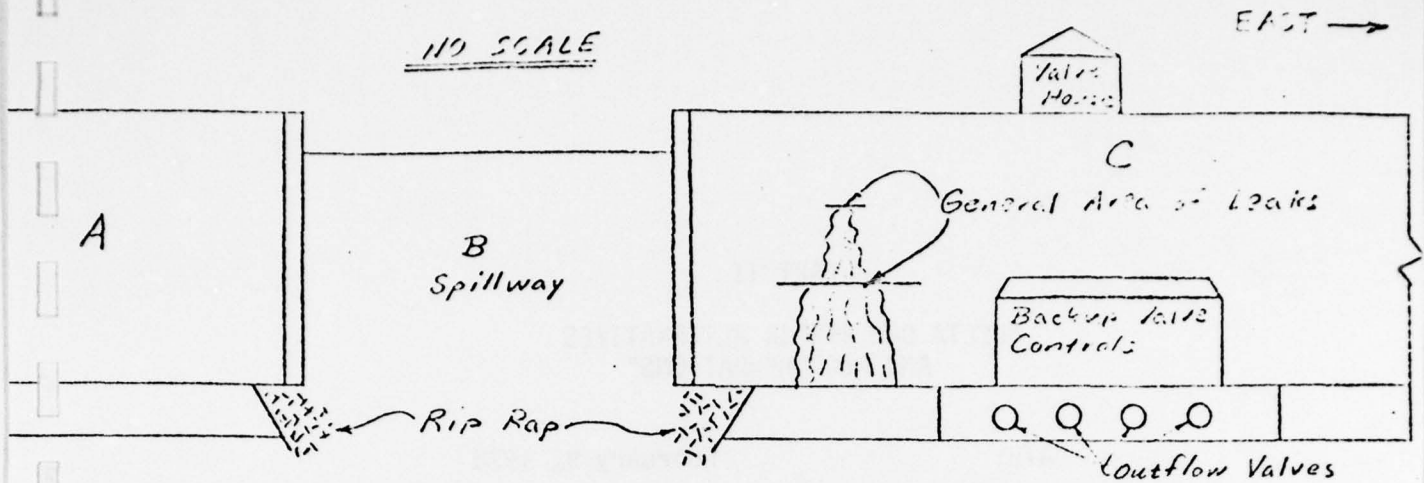
DIAGRAM I: GENERAL VIEW OF DELTA DAM

Observations a-h address themselves to options 1 & 2 on pages 3 and 4 of this Trip Report. Referring to options 3 and 4 on page 4 of this Trip Report, we did no exploratory chipping of the concrete in the area of leak one. Neither did we pursue the infrared photograph option any further.
